# Huntington Townhomes Bldg 1 Wind Mit Update

## Huntington Townhomes Bldg 1 Wind Mitigation

### Wind Mitigation Inspection Report

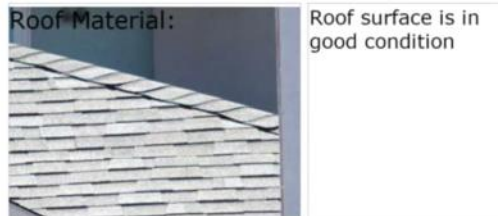
| Roof Geometry: | Non-Hip | | |

Notes:  
Gable end walls and/or non-hip features are greater than 10% of total perimeter
