# Huntington Townhomes Bldg 2 Wind Mitigation

## Wind Mitigation Inspection Report

By: Fair Wind Inspections Inc.

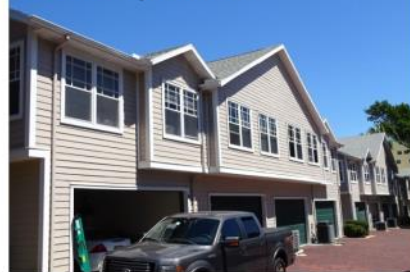
Geometry Picture

Roof Geometry:	Non-Hip		
Total Non-Hip	N/A	Total Perimeter:	N/A
Less Than 2:12:	N/A	Total Area:	N/A

Gable end walls and/or non-hip features are greater than 10% of total perimeter

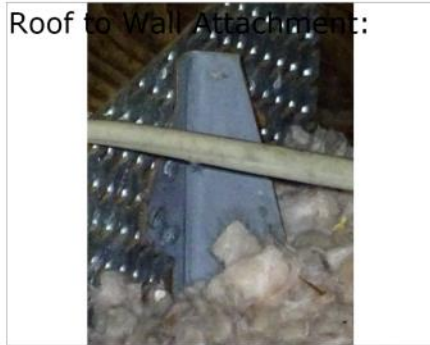
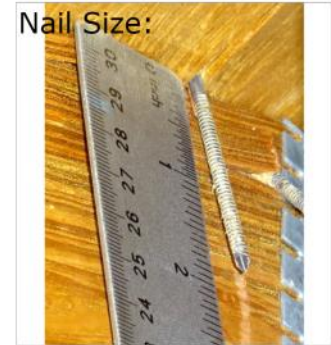
Clip Type:   
 Nails Per Clip:

Notes: Clip on each truss attaching it to the top of the wall

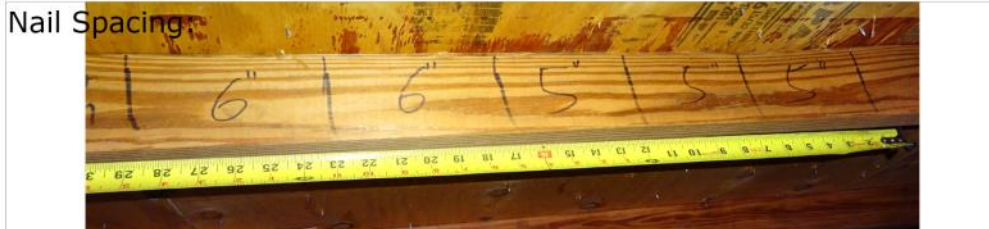
Deck Thickness:   
 Nail Size:   
 Nail Spacing:   
 Underside of roof is in good condition
