# Huntington Townhomes Bldg 4 Wind Mitigation

## Wind Mitigation Inspection Report

By: Fair Wind Inspections Inc.

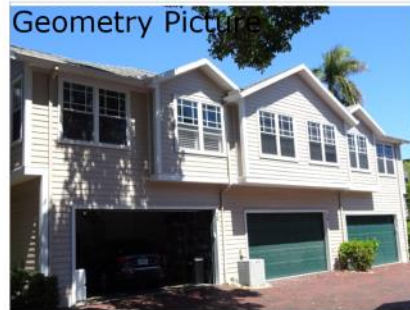
Geometry Picture

Roof Geometry: Non-Hip  
 Total Non-Hip: N/A Total Perimeter: N/A  
 Less Than 2:12: N/A Total Area: N/A

Roof surface is in good condition

Gable end walls and/or non-hip features are greater than 10% of total perimeter

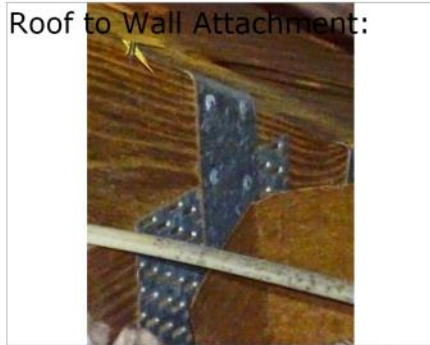
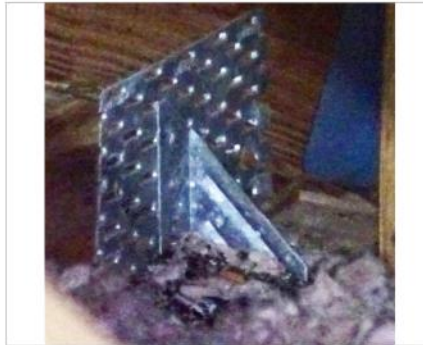
Clip Type: Clips  
 Nails Per Clip: 3-4

Notes: Clip on each truss attaching it to the top of the wall

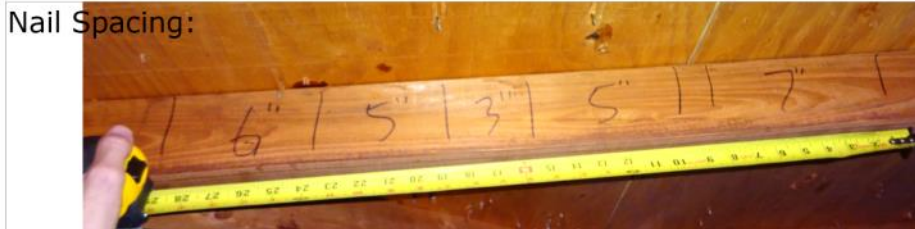
Roof Deck Thickness:

Deck Thickness: 1/2" Plywood  
 Nail Size: 8d Ring Shank  
 Nail Spacing: 6" or less

Underside of roof is in good condition
